SALSA On Ice Report: 08-14 November 2017

Drill Team Update by Justin Burnett

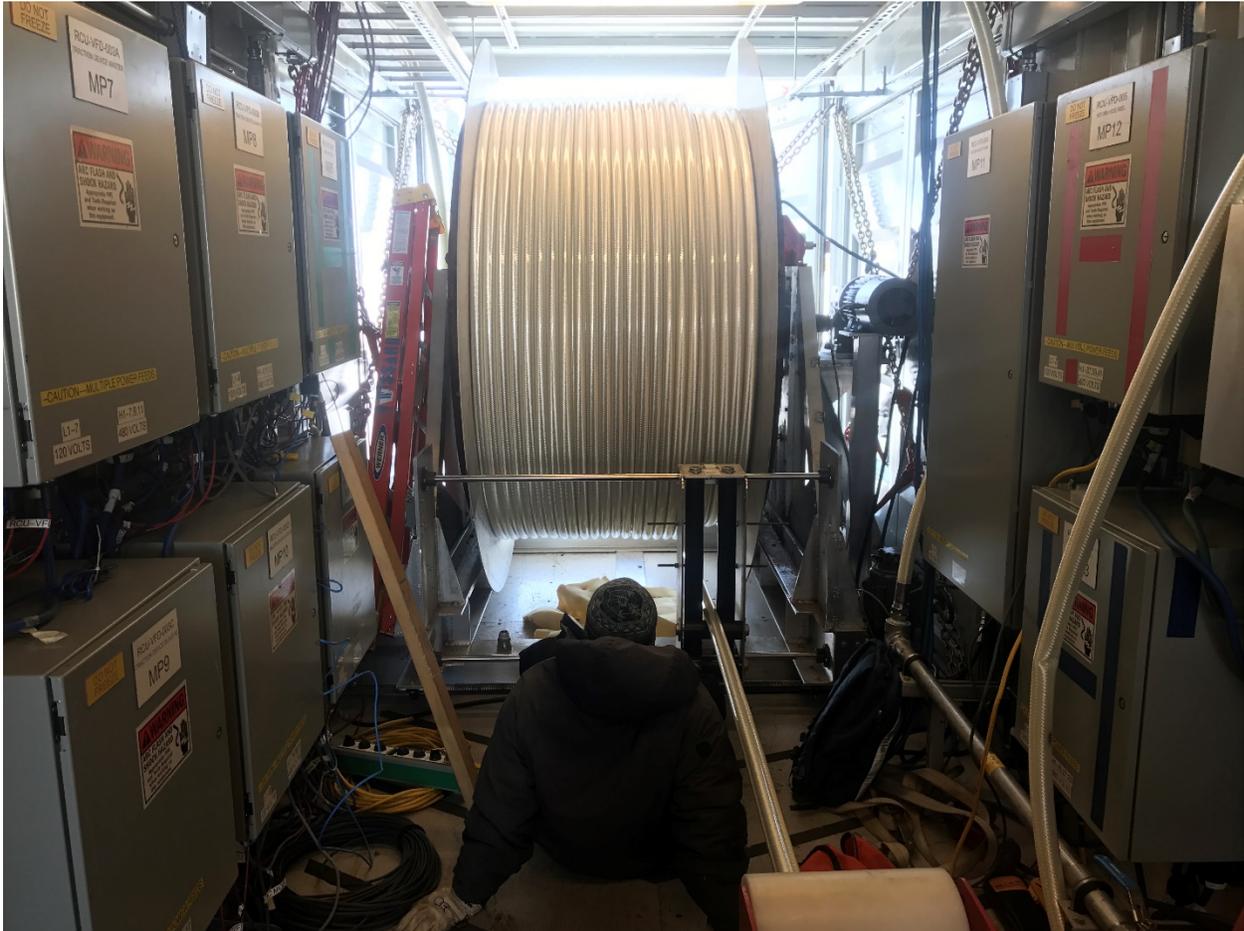
- Spent all day spooling an additional 400m of hose onto the main hose reel this operation was successful with only minor issues
 - Tension was maintained by the traction device, with the jaw-open position adjusted to support the weight of the upper section, while opening just enough to maintain belt contact on the drill hose. Only the rear (main hose reel side) half of the traction motors were engaged
- During system startup an issue was discovered with the main reel manual (local backup) control, failing to respond to the input speed reference from the speed dial located on the pendant control. Trouble shooting revealed the correct setting location, but this error

persists. Regardless, this strictly a minor inconvenience, and system appears to be otherwise operational
